Subject: Geologic Testing at the West Parcel, Mount San Antonio College

# Geologic Testing

WEST PARCEL SOLAR PROJECT

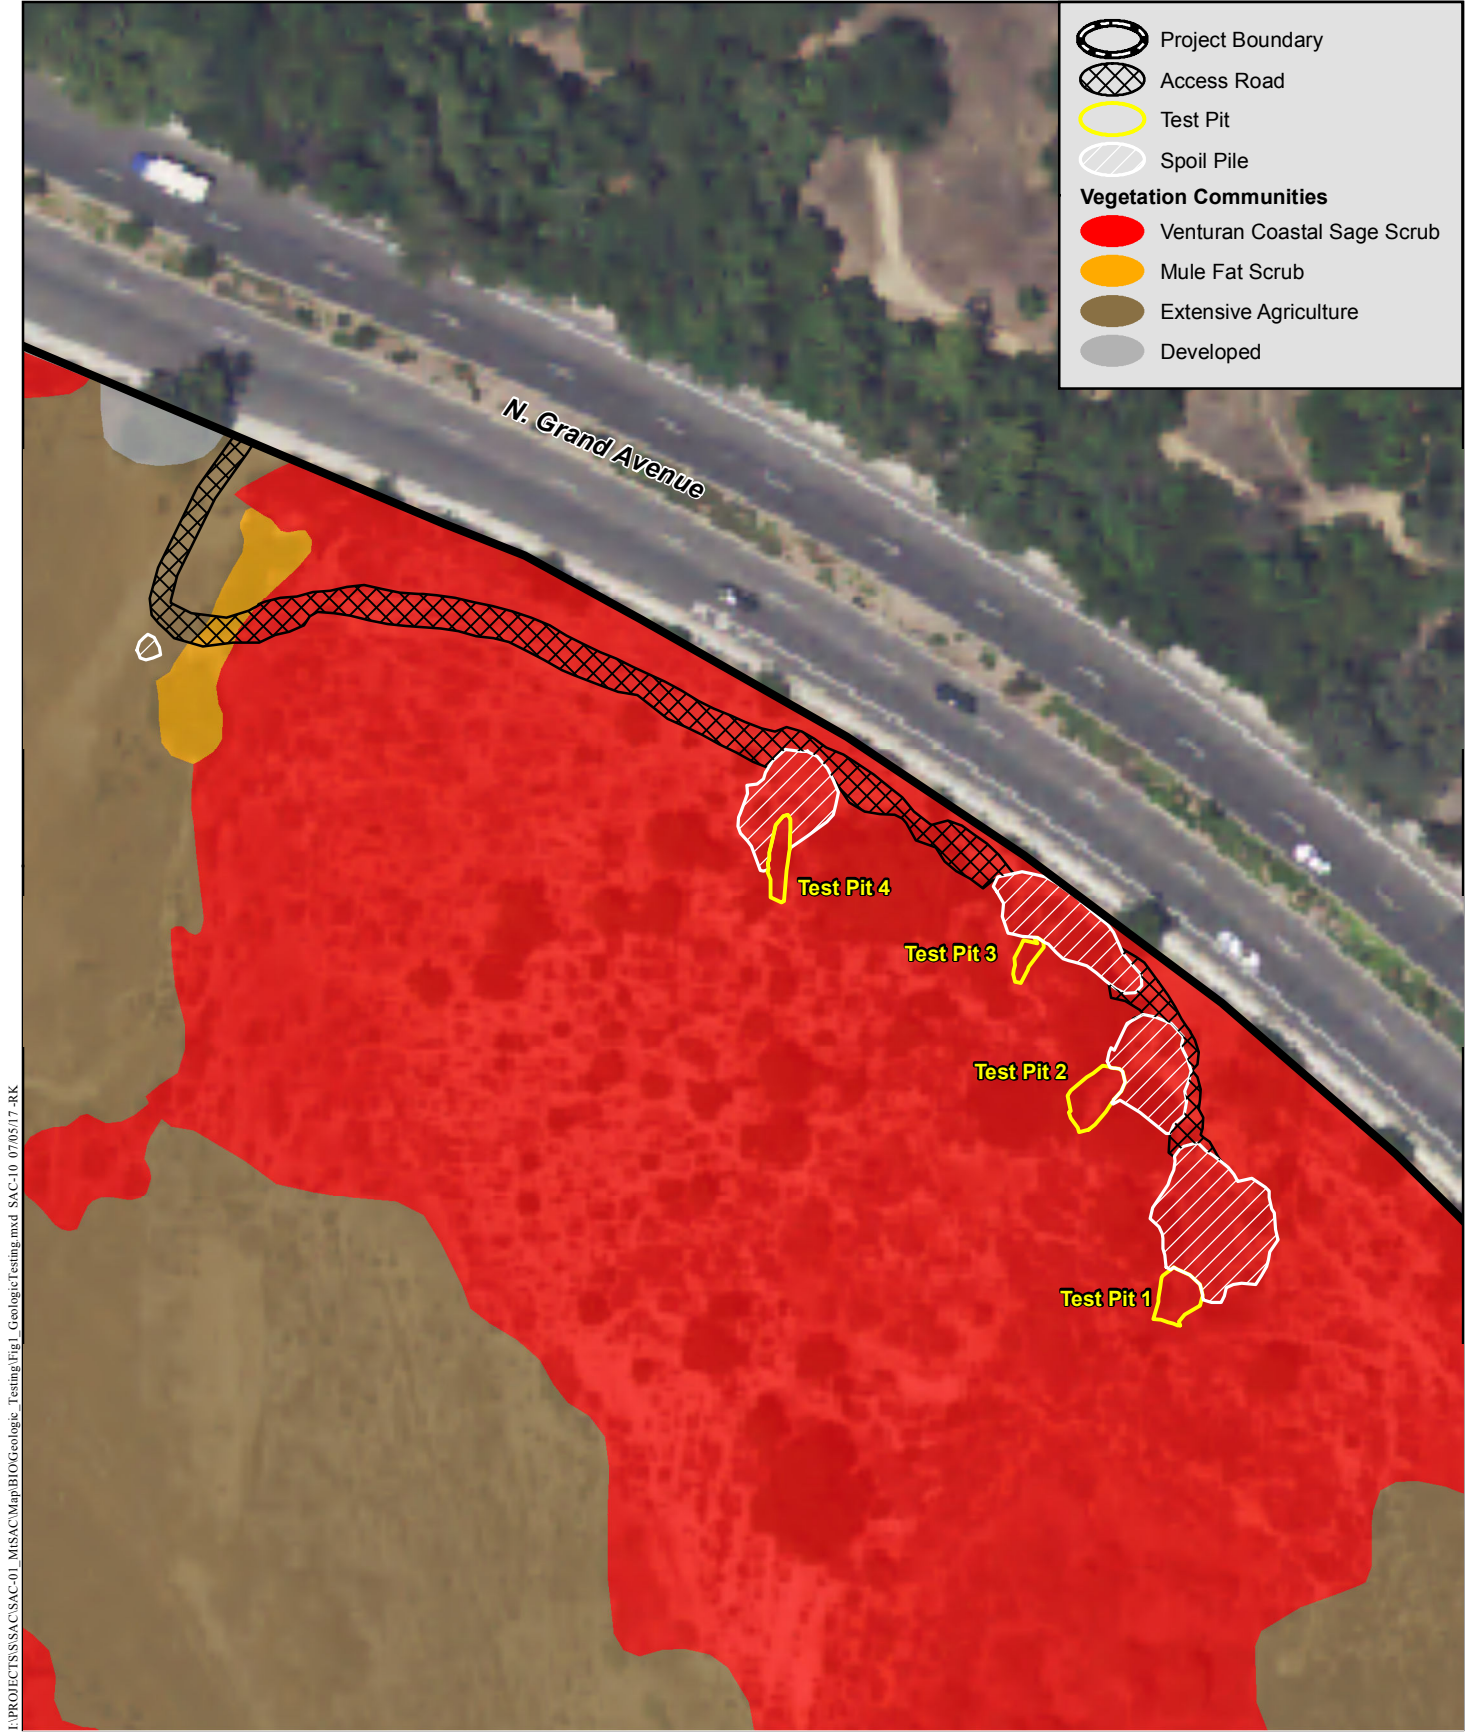
On June 12, 2017, four test pits were excavated on the West Parcel at Mt. SAC to investigate a landslide area in preparation for future grading (Figure 1). The test pits were dug using an excavator.

The footprint from the geologic testing was overlaid on a vegetation map previously prepared by HELIX (Figure 1). This is the same mapping that was used in the acquisition of project permits. The vegetation affected included 0.243 acre of Venturan coastal sage scrub, 0.004 acre of mule fat scrub, and 0.019 acre of extensive agriculture (Table 1). The total impacts were just over one-quarter acre, or 0.266 acre.

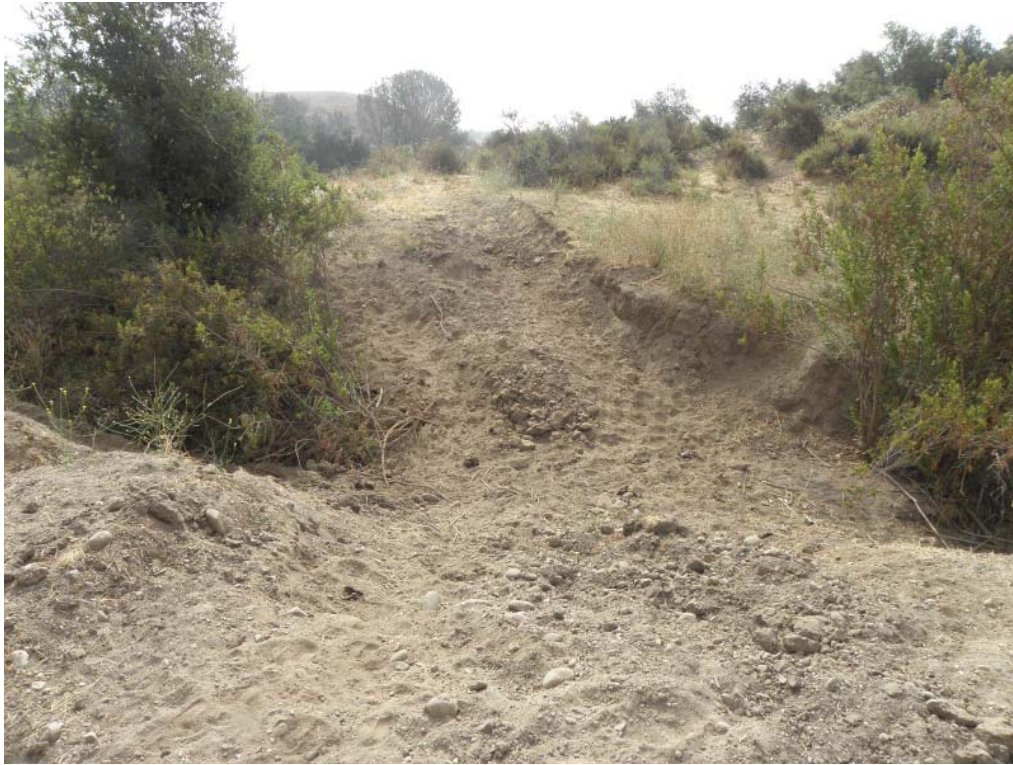
**Streambed Crossing**

The mule fat scrub impacts were associated with a new streambed crossing. The streambed was dry at the time and has remained so since. The banks of the streambed were graded to a lower angle and some of the spoils are currently in the streambed. It appears that a small number of shrubs were affected.

Mule fat scrub removed and minor earthwork done at this location.

Looking south across streambed.

Mt. SAC proposes to remove the spoils from the streambed with manual labor (e.g., shovels and wheel barrows), and install straw wattles at the outer edge of the streambed. Jute matting, or similar, will also be installed on the disturbed banks of the streambed.

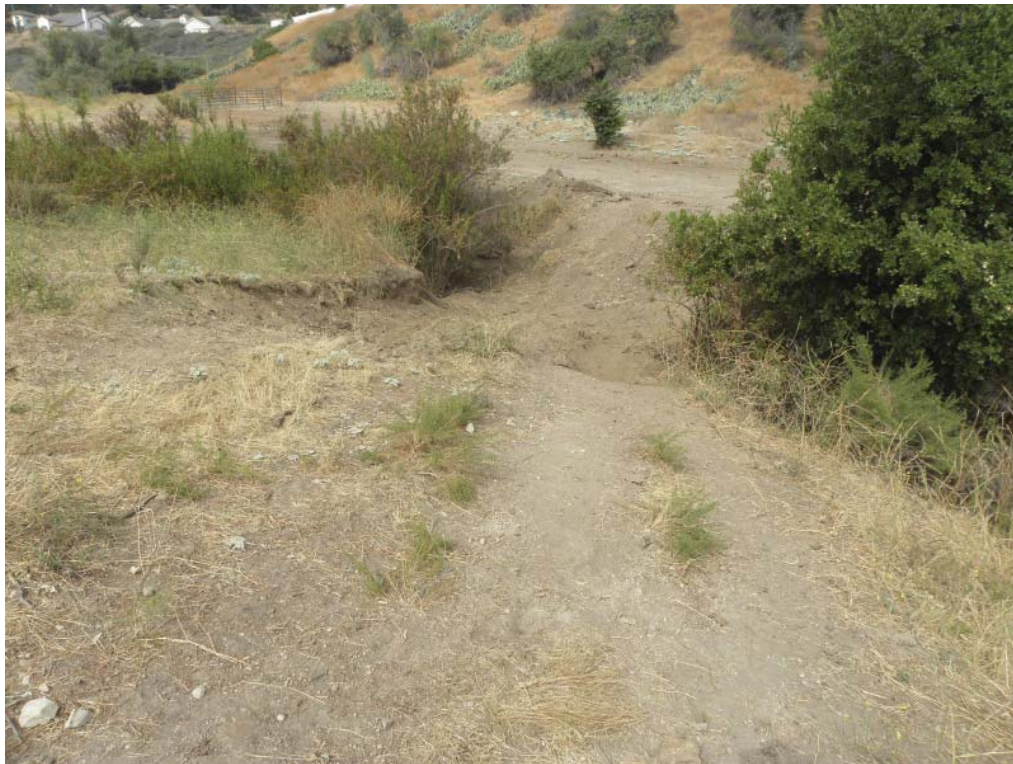
Looking north across streambed.

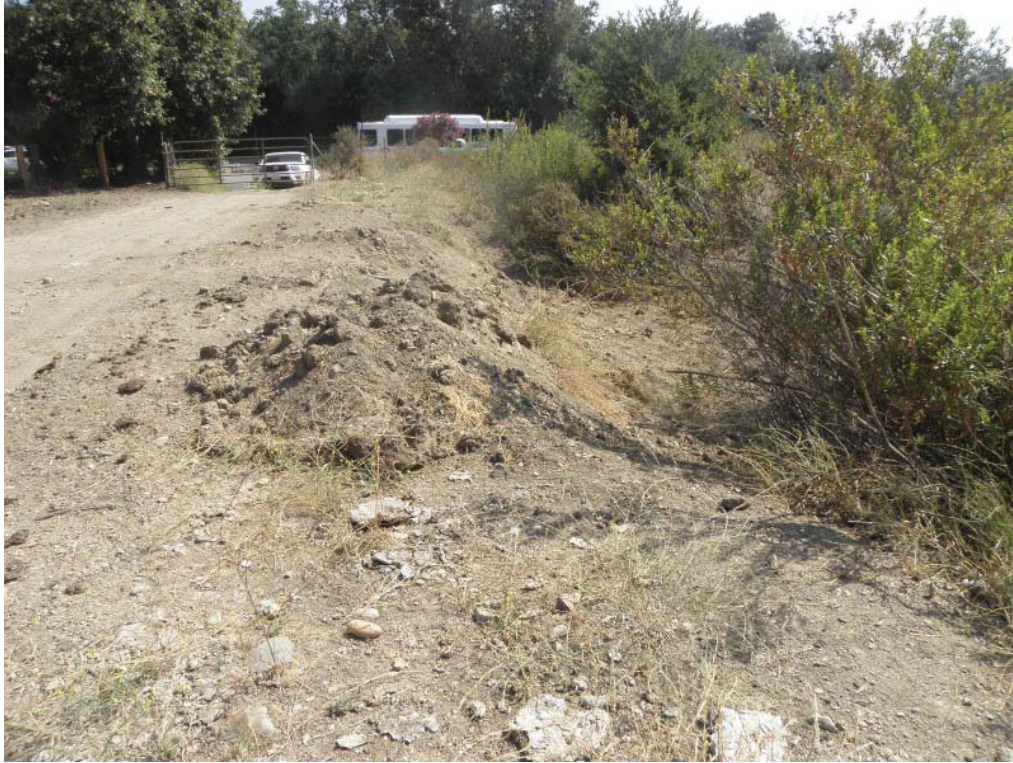
**Streambed Crossing**

Mule fat scrub removed and minor earthwork done at this location.

Looking east along north side of streambed.

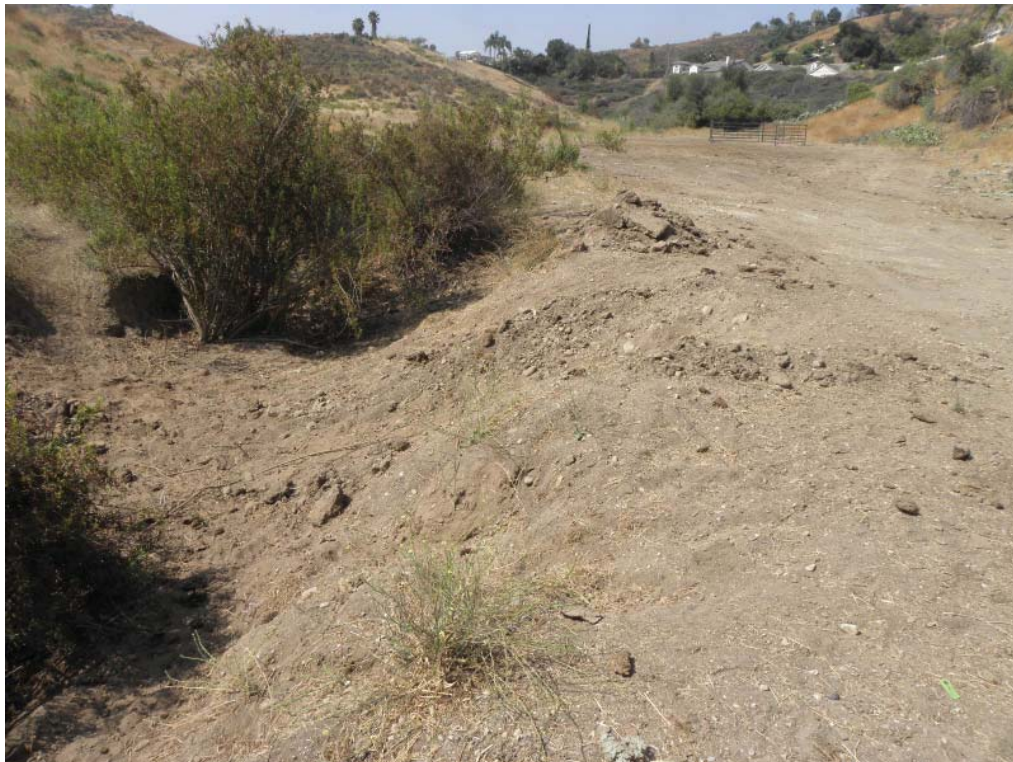
Looking west along north side of streambed.
